APPENDIX A
CITY OF PASCO REACH
CHARACTERIZATION TABLES AND
REACH MAPS

Reach 1	City of Pasco
Reach Description: Columbia River from City of Pasco boundary to Interstate 182 bridge	
Shoreline Jurisdiction: 368 acres

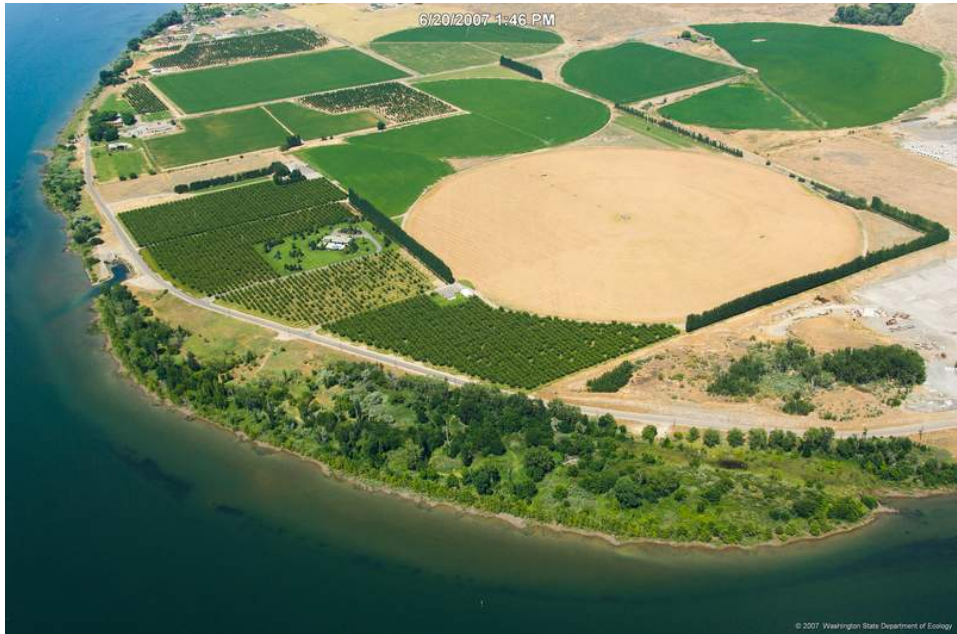
Reach 1	City of Pasco
Existing Land Cover/Development: Reach 1 includes a mix of natural unimproved land, riparian vegetation, agricultural land, roads, utilities, and residential structures. SR 1b and SR 1e include residential and accessory structures. SR 1c includes a boat dock, irrigation pump, and parking. SR 1d includes a boat launch.	
Geomorphic Character: Description: The shoreline throughout the reach consists of mostly of outburst flood deposits with relatively low banks. In addition, a minor amount of alluvium and sand dune deposits are located at the most downstream extent of the reach (SR 1e). Residential and some industry infrastructure are present along the shoreline throughout Reach 1. Hardened Banks: A minor amount of hardened banks appear to exist along the Reach 1 extent and is primarily associated with the Interstate 182 bridge crossing at downstream extent (SR 1e).	
Flooding and Geological Hazards: Flooding: Flooding is regulated by upstream dam operations and Lake Wallula pool elevation controls (SR 1d and SR 1e). Geological Hazards: SR 1b, 1c, and 1d have soils susceptible to erosion. SRs 1d and 1e contain slopes that are greater than 15% and underlain by dune sand, which make them designated landslide hazard areas.

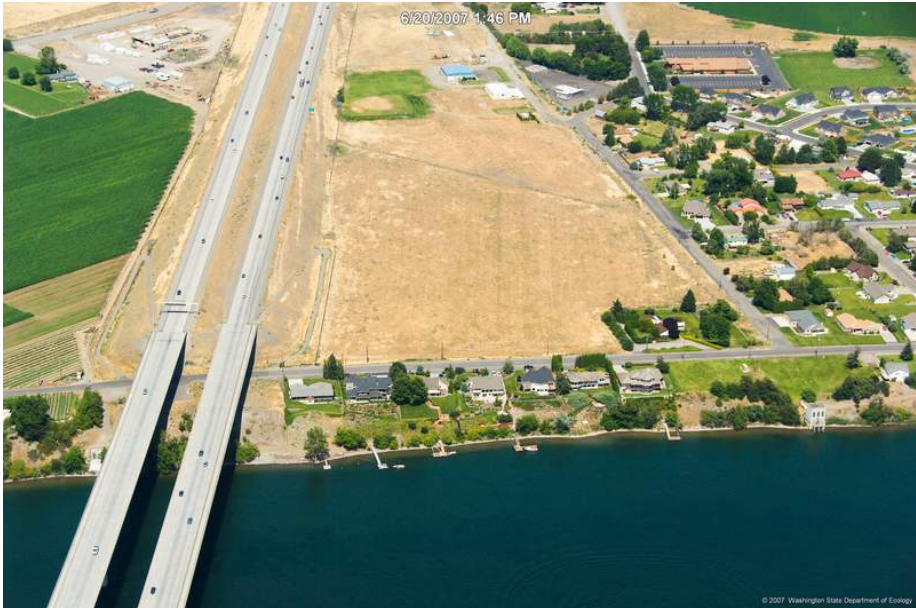
Reach 2	City of Pasco
Reach Description: Columbia River from Interstate 182 bridge (City limits boundary) to the end of waterfront residential developments	
Shoreline Jurisdiction: 102 acres

Geomorphic Character: Description: The shoreline throughout the reach consists of outburst flood deposits with relatively low banks. Moderate-density residential infrastructure is present along the shoreline throughout this reach.

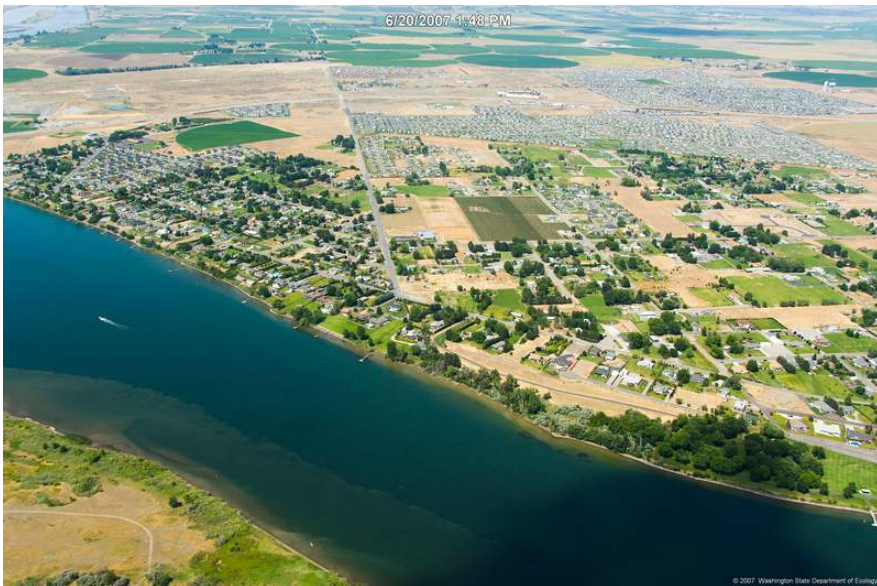
Reach 3	City of Pasco
Reach Description: Columbia River from the upstream end of Chiawana Park to the edge of the hardened bank	
Shoreline Jurisdiction: 382 acres

Geomorphic Character: Description: The shoreline throughout the reach consists of outburst flood deposits with relatively low banks.

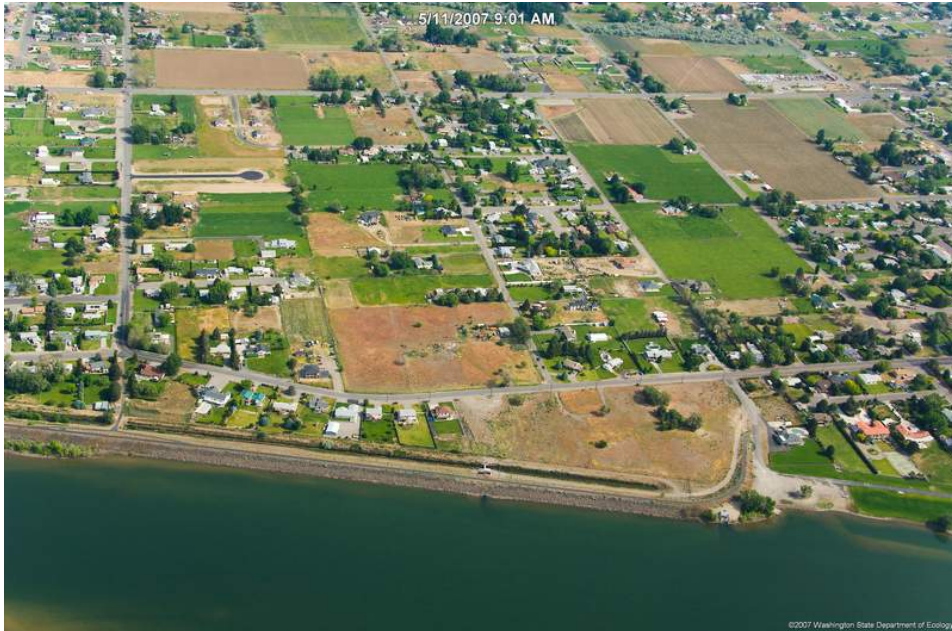
Reach 4	City of Pasco
Reach Description: Columbia River from the upstream edge of hardened bank to the downstream end of Wade Park	
Shoreline Jurisdiction: 463 acres

Current SMP Environment Designation: Urban	
Existing Land Cover/Development:	
There is a levee along the entire stretch of SR 4a and parkland along the entire stretch of SR 4b. SR 4a groundcover consists mostly of riprap with a trail on top of the levee and some riparian vegetation. SR 4b groundcover consists of improved parkland (Wade Park) with a boat launch, piers, a trail, and gravel parking.

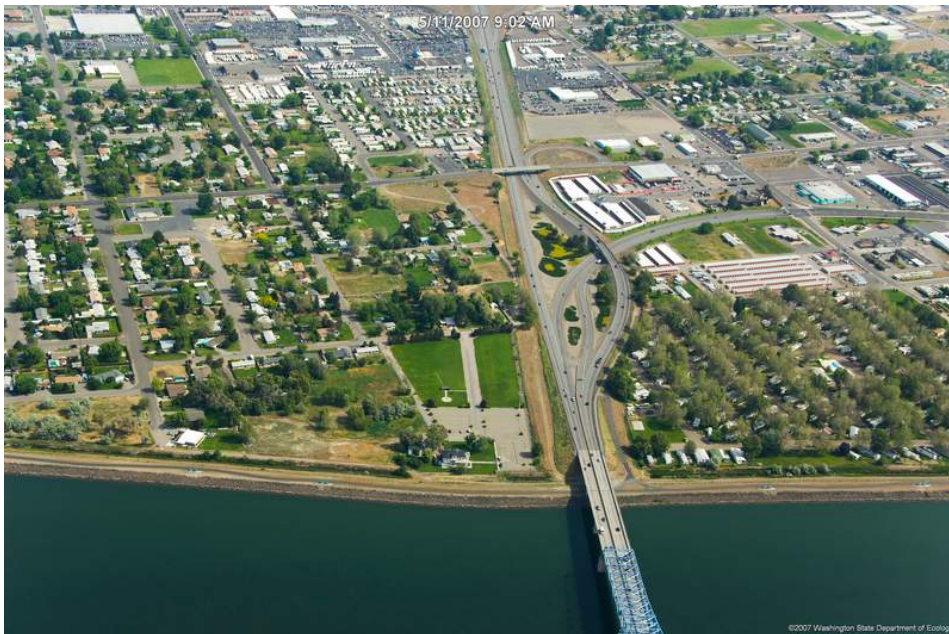
Reach 5	City of Pasco
Reach Description: Columbia River from the edge of hardened bank upstream of US 395 (Blue Bridge) to State Route 397 bridge (Cable Bridge)	
Shoreline Jurisdiction: 195 acres

Reach 5	City of Pasco
Existing Land Cover/Development: Reach 5 is primarily consists of a levee, riprap, a drainage ditch behind the levee, and a trail on top of the levee. There is riparian vegetation, parking, and a park facilities structure on SR 5c. A rail line on SR 5d is near the Blue Bridge.	
Geomorphic Character: Description: The shoreline throughout the reach consists of alluvium with relatively low banks through urban development area. Hardened Banks: Approximately 10,500 linear feet of artificial hardened banks exist along the Columbia River (left bank).	
Flooding and Geological Hazards: Flooding: Flooding is controlled by Lake Wallula pool levels. Levees are present along the reach, which reduce flooding potential. Geological Hazards: There are no geologic hazard areas in Reach 5.	
Existing Public Access: Reach 5 contains the Sacajawea Heritage Trail and Riverview Park. Similar to Reach 4, access points to the trail are limited due to the levee and drainage ditch behind the levee. Identified Public Access Improvements: The Rivershore Linkage and Amenity Plan (Pasco 2012) recommends improving the open space area near W. Havstad Street, adding beach area at the Wade Park entrance and south of the Riverview Park, adding a multi-use path over the Blue Bridge, developing the levee, and improving access from the levee to the river.

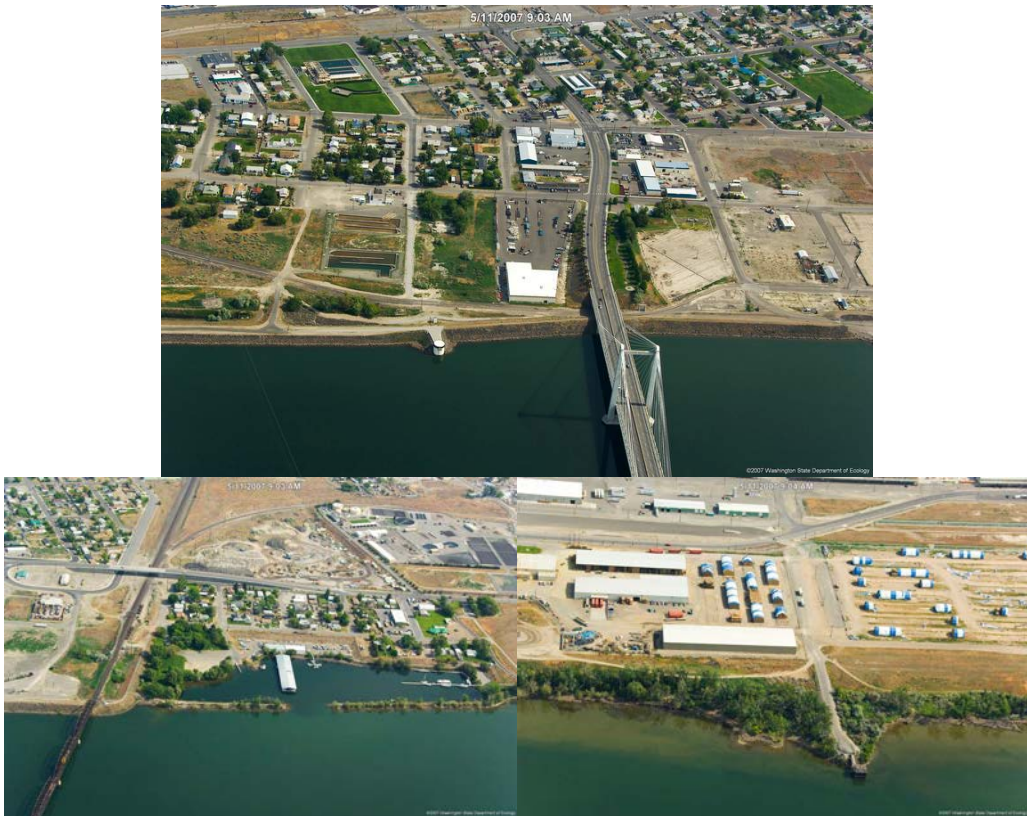
Reach 6	City of Pasco
Reach Description: Columbia River from State Route 397 (Cable) bridge to the upstream edge of Sacajawea State Park	
Shoreline Jurisdiction: 744 acres

Reach 6	City of Pasco
Current SMP Environment Designation: Urban	
Existing Land Cover/Development: Reach 6 consists of a mix of riprap, riparian vegetation, a trail, a marina, residential structures, warehouses, parking, unimproved vacant land, and industrial land. SR 6a is mostly riprap that includes a barge dock. SR 397 crosses the shoreline on SR 6a. SR 6b has riparian vegetation around the marina and Schlagel Park. Industrial land cover dominates SR 6c. There is riparian vegetation on the edge of the shoreline in SR 6b and 6c.	
Geomorphic Character: Description: The shoreline throughout the reach consists of alluvium with relatively low banks through a developed area. Hardened Banks: Approximately 6,500 linear feet of artificial hardened banks exist along the Columbia River (left bank) within all the subreaches.	
Flooding and Geological Hazards: Flooding: Flooding is controlled by Lake Wallula pool levels. Levees are present along SR 6a, which reduce flooding potential. Geological Hazards: There are no geologic hazard areas in Reach 6.

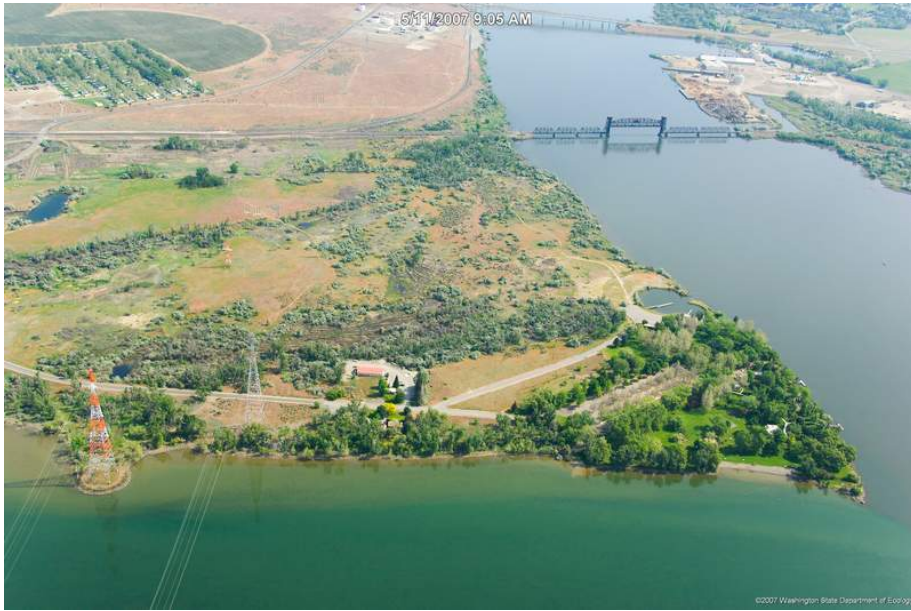
Reach 7	City of Pasco
Reach Description: Columbia River from the upstream edge of Sacajawea State Park to Snake River just east of the Sacajawea State Park boat basin	
Shoreline Jurisdiction: 295 acres

Geomorphic Character: Description: Reach 7 consists of a topographic low area at the confluence of the Columbia River and Snake River. The shoreline throughout the reach consists of alluvium with relatively low banks throughout Sacajawea State Park.

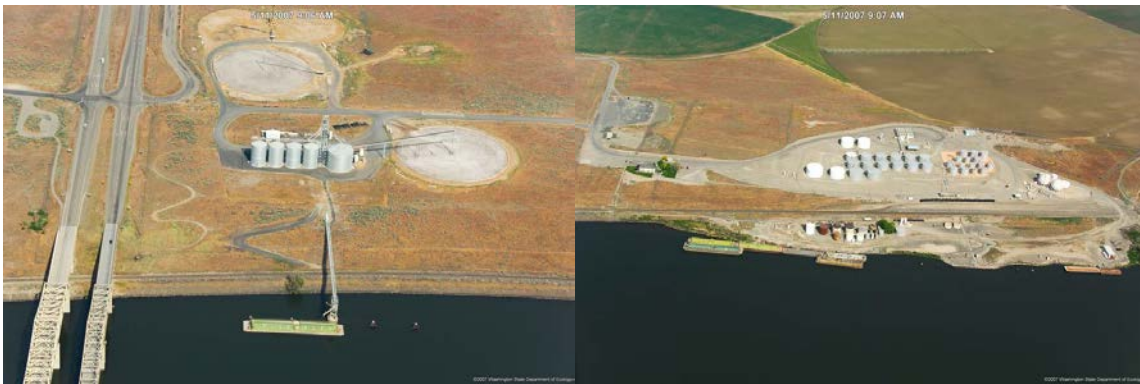
Reach 8	City of Pasco
Reach Description: Snake River just upstream of confluence with Columbia River, extending from City UGA eastern boundary to near Sacajawea State Park	
Shoreline Jurisdiction: 260 acres

Existing Land Cover/Development: SR 8a is mostly unimproved natural land with riparian vegetation. SR 8a includes a rail crossing. SR 8b includes State Route 12 crossing, a fuel storage tank, and barge facilities.	
Geomorphic Character: Description: The shoreline in this reach consists mostly of outburst flood deposits. The reach consists of low bank areas near the confluence with the Columbia River. Lake Wallula levels fluctuate with downstream dam management practices. Hardened Banks: Approximately 7,200 linear feet of artificial hardened banks exist along the Columbia River (left bank) within all the subreaches.
